Voluntary Site Contamination Assessment Proposal (VSCAP)

Historical Pasadena Landfill

PREPARED FOR:	Environment Protection Authority South Australia (EPA)
COPY TO:	Kathryn Walker - Piper Alderman; Jarrod Bishop - LBW co
PREPARED BY:	City of Mitcham
DATE:	23 September 2020
VARIATION NO:	0

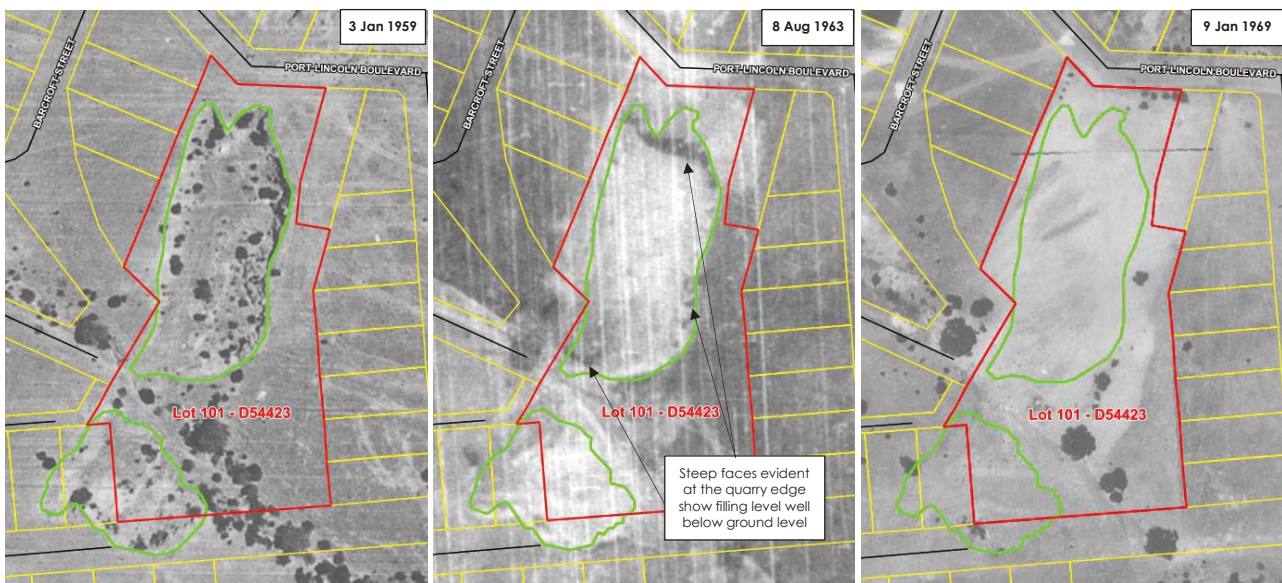
There are no records to demonstrate the elevation of the landfill surface at cessation of waste disposal activities at the site by City of Mitcham around 1962. However, the 1963 aerial photograph (Mapland, DEW) shows the landfill surface within the quarry to be well below the natural ground level at the quarry edge at that time. Extracts of the 1959, 1963 and 1969 aerial photographs below show the progression of filling of the quarry (green line shows extent of quarry) through to completion during this period. No waste or fill material was placed on the site by the City of Mitcham after 1962, but it is evident that substantial landfilling occurred after this period under the control of Mr Eberhard.

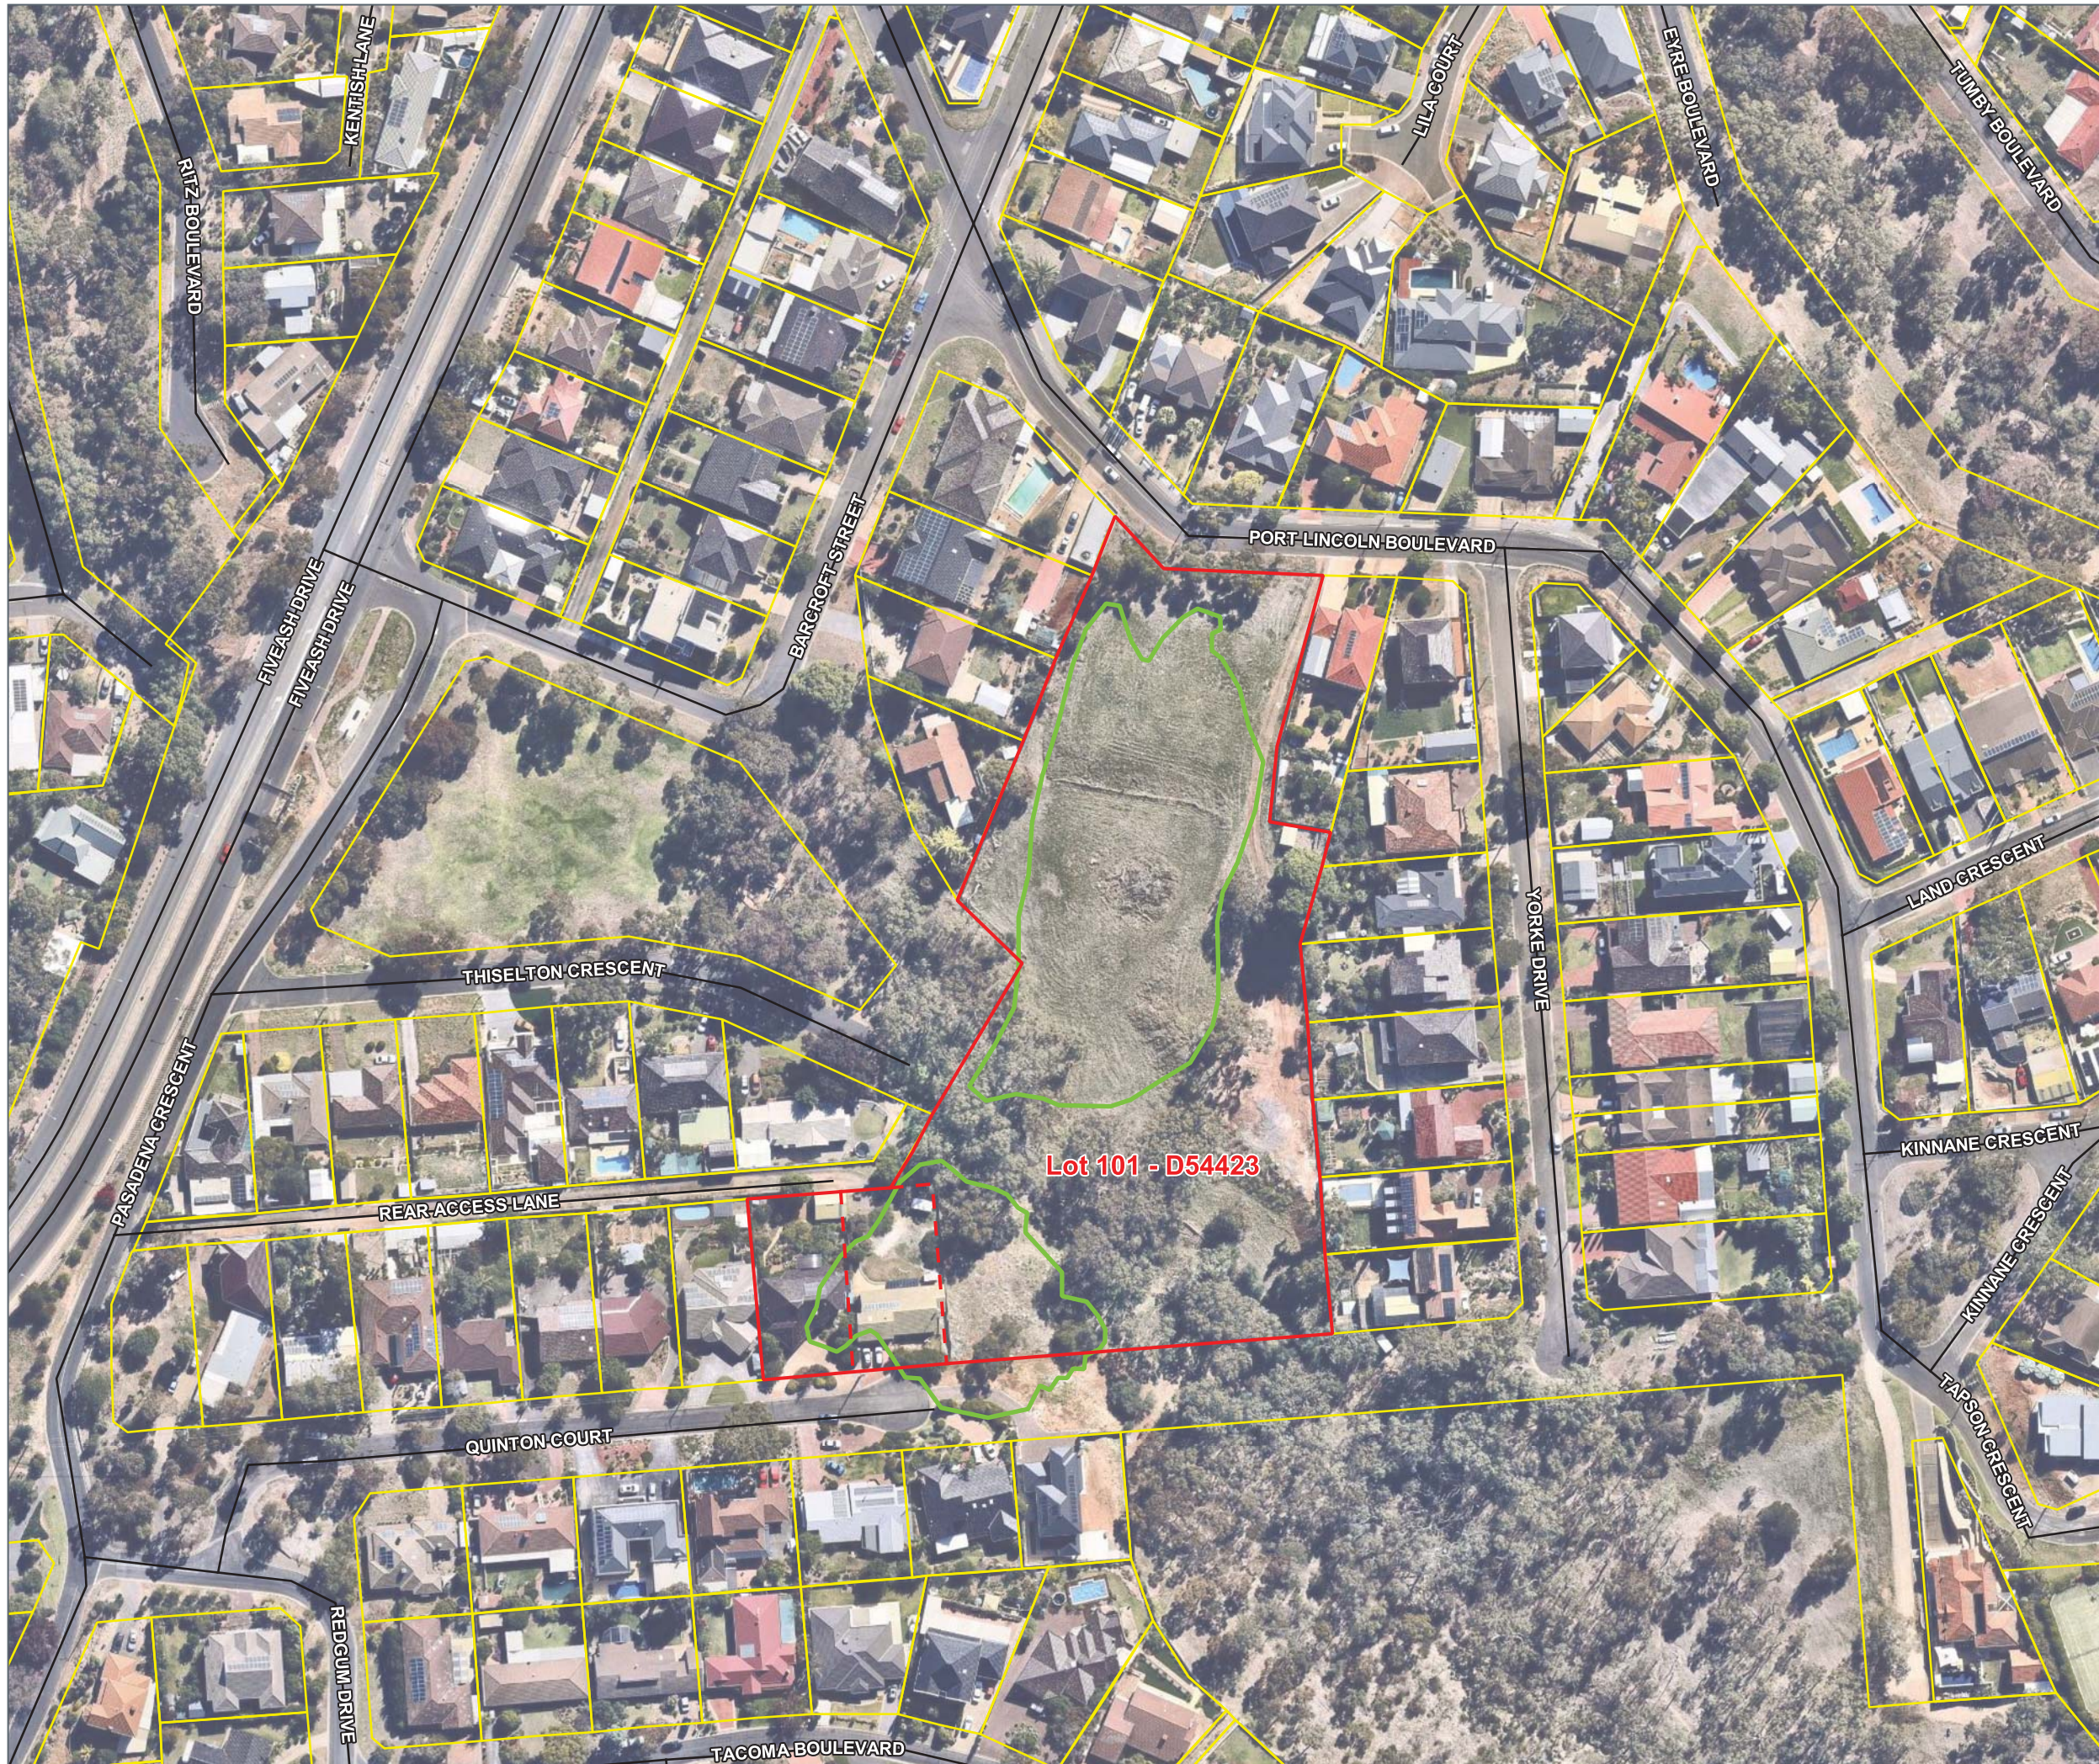
FIGURE 2
2020 Aerial Photograph

- LEGEND**
- Road
 - Approximate extent of quarry in 1959
 - Cadastral Boundary
 - Site Boundary
